# MARINE FISHERIES INFORMATION SERVICE

No. 75  
SEPTEMBER 1987

# BEACH EROSION AT KOVALAM FISHING VILLAGE, TAMIL NADU, WITH SOME COMMENTS ON THE SEASONAL SHIFTS IN THE COASTLINE ALONG THE KOVALAM BAY\*

\*Prepared by Geeta Bharathan and E. V. Radhakrishnan, Madras Research Centre of CMFRI, Madras.

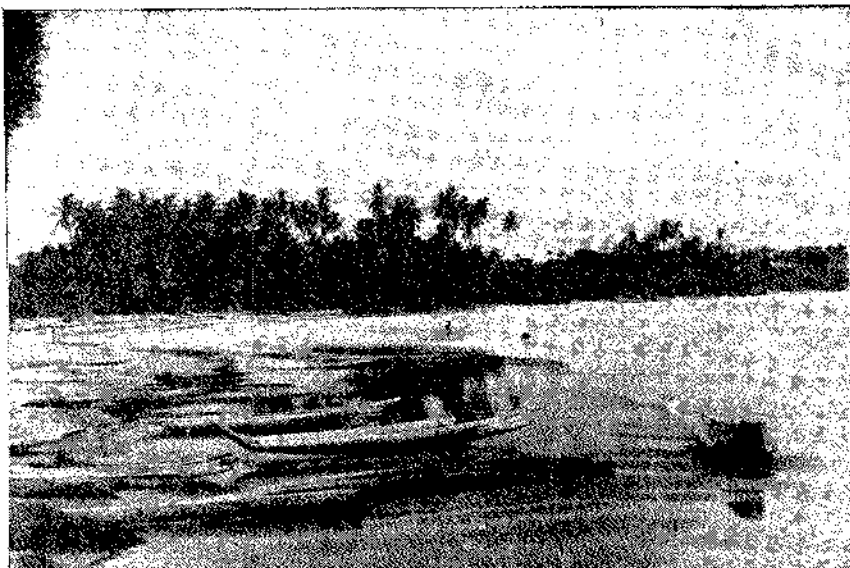
Fig. 2. The Kovalam beach in July, 1985. Note the flat profile of the beach compared to the sand mound in Fig. 10.

settlement, consisting of thatched, as well as 'pukka' houses, is located very close to the sea on a sand mound of 2 m high. These houses were hidden behind a thick grove of coconut palms (Fig. 2) until calamity in the form of severe sea erosion struck the village during May-June, 1986. Over 150 coconut palms and 13 houses were destroyed (Fig. 3 & 4) and several others damaged severely, affecting the livelihood of many households. Temporary relief came in the form of piles of sand bags (Fig. 5) to prevent further damage. The sea receded by the last week of June and there was no further threat to the village.

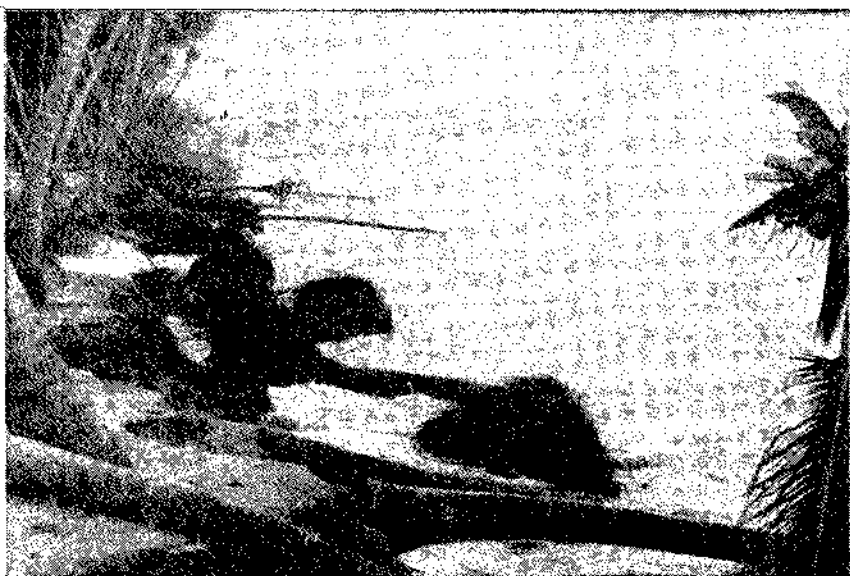
Fig. 4. Close-up view of erosion, 30th May, 1986.

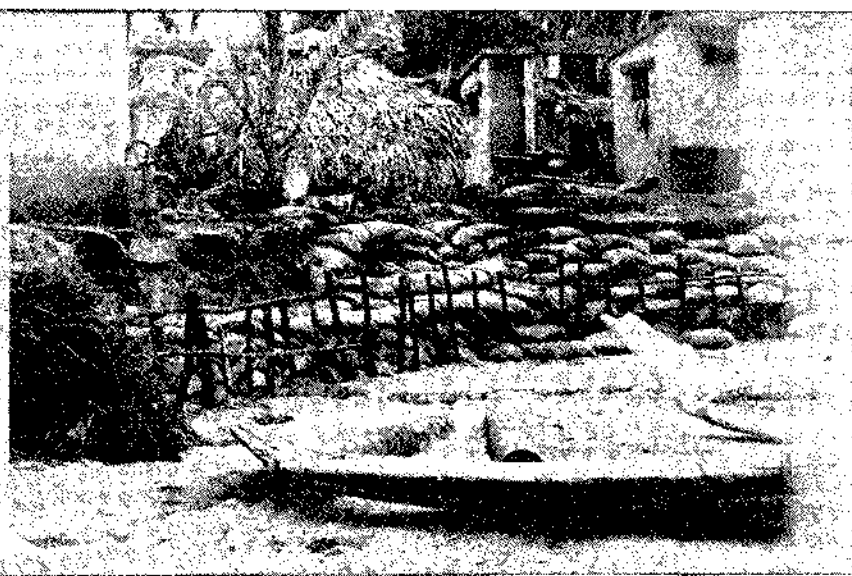
Fig. 5. Sand bags stacked on eroded beach in front of the houses for temporary protection.
